Light detection and ranging (LiDAR) and multispectral studies of disturbed Lake Superior coastal environments

W. Charles Kerfoot,^{a,b,*} Foad Yousef,^{a,b} Sarah A. Green,^c Robert Regis,^d Robert Shuchman,^{d,e} Colin N. Brooks,^e Mike Sayers,^e Bruce Sabol,^f and Mark Graves ^f

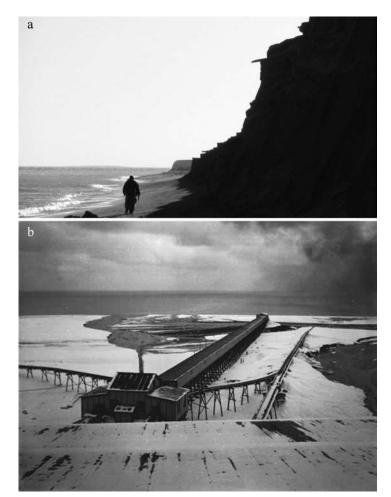
Fig. 7. (a) Wave erosion of the Gay tailings pile. The near-vertical 7-m bluffs contain wellpreserved remnants of wooden troughs that sluiced stamp sands across the pile. (b) Primary and secondary sluiceways (Wolverine Mill, winter 1922) carry stamp sands over the Gay pile. Lake Superior is on the horizon. Notice melted regions with fresh discharges. Photo courtesy of Michigan Tech Archive.
