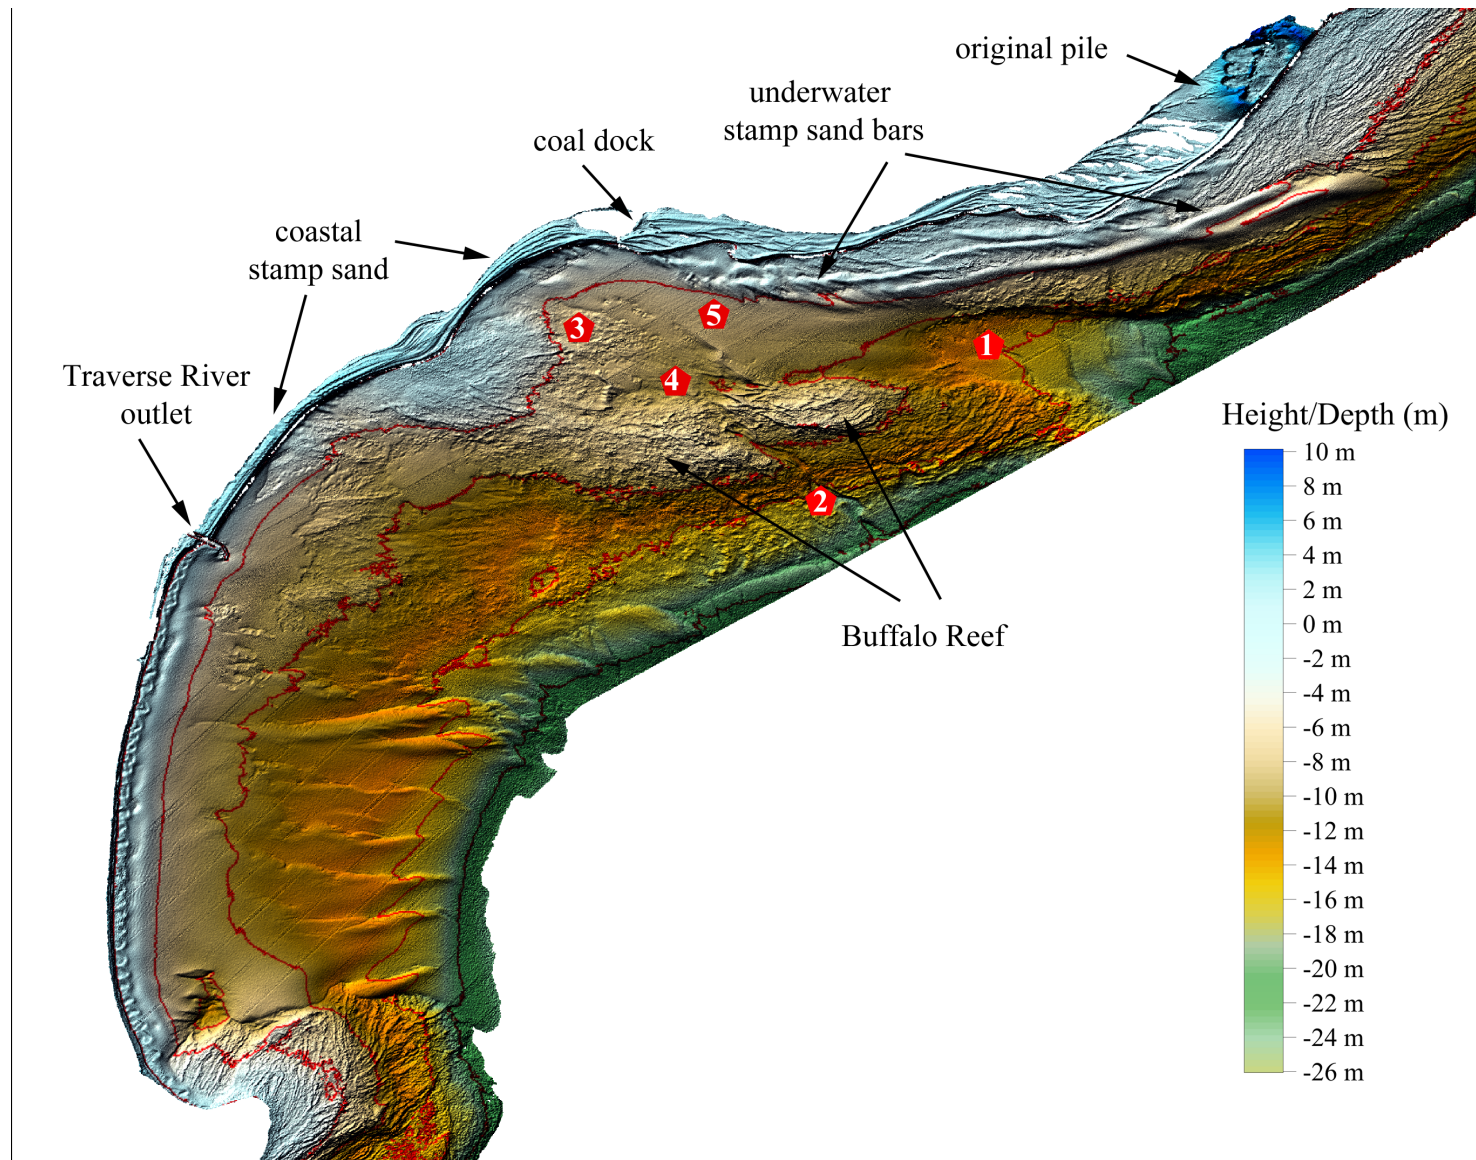
Fig. 3. NOAA 2010 LiDAR of Grand (Big) Traverse Bay, color-coded by elevation and water depth, with additional 5-m horizontal red lines. Image shows erosion of original Gay tailings pile, migration of underwater stamp sand bars across Jacobsville Sandstone bedrock and deposition into an ancient river cut (#5 mounding in the “trough”; #1 lower reach cut through bedrock). Stamp sand from “trough” is moving into northern cobble fields of Buffalo Reef (#3,#4) and into a canyon cut (#2). Stamp sand is also found west of promontory and east and south of Traverse River Seawall. Natural sand moves from lower white sand beach out into Keweenaw Bay.
